Bennett Marine Inc.
Technical Service Bulletin 0145-15
April 17, 2015

EIC Relay Modules, 12V only. Part # EIC101DAD

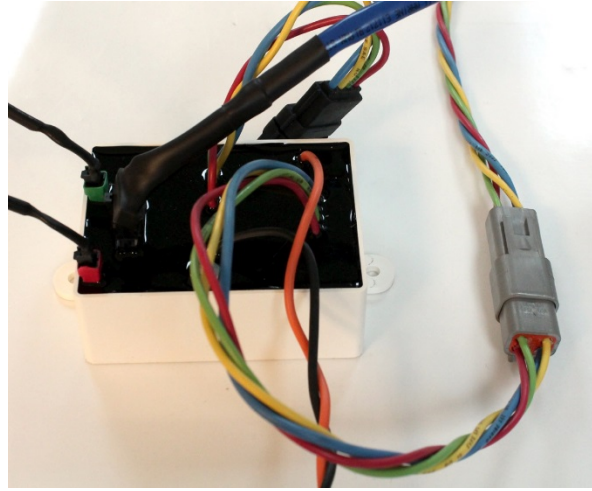
EIC101DAD. The product label is located on the bottom of the unit and must be uninstalled to view.

White plastic box 3- $\frac{3}{4}$ " Long, 2- $\frac{3}{4}$ " Wide, 1- $\frac{1}{2}$ " Tall
Black Potting on top of box.
