YAMAHA MARINE SYSTEMS COMPANY, INC. 1270 Chastain Road NW, Kennesaw, GA 30144-5586 (866) 894-1626

IMPORTANT SAFETY RECALL NOTICE

January 25, 2023

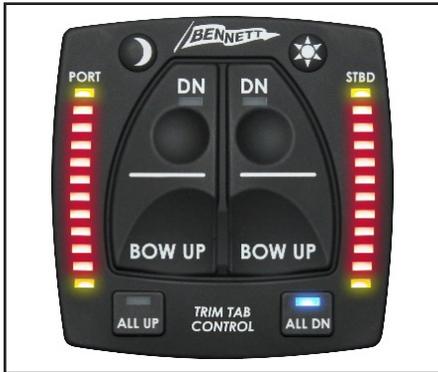
OBI9000E Integrated Control unit

Yamaha Motor Co., Ltd. in conjunction with Yamaha Marine Systems Company, Inc. has decided that a defect that relates to safety may exist in certain helm control units commonly used with BOLT Electric Trim Tabs. In affected helm control units, which are in a revision "A" lot, internal components may overheat during normal operation, which could result in damage to the control unit and surrounding areas.

To correct this defect, Yamaha Marine Systems Company is initiating a Factory Modification Campaign (Recall). Affected OBI9000E Integrated Helm Control units must be inspected and, if found to be in the defective lot, replaced with revision "B" or newer OBI9000E units. **NOTE:** This recall campaign does not involve the equivalent control unit for hydraulic trim tabs (model OBI9000H).

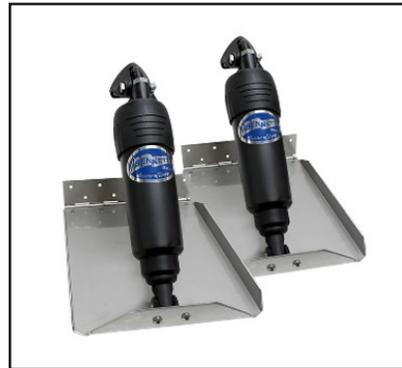
Affected Integrated Helm Control is used with BOLT Electric Trim Tabs

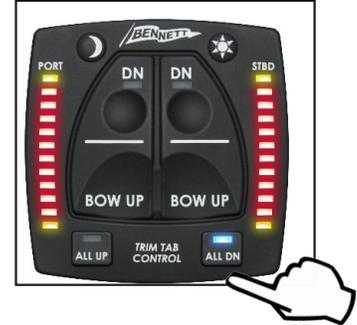
Corner lights turn off
– proper operation
